### Resetting of Indented Button on Instrument Panel

TG-NP-0004

Rev A | 26 Oct 2015 | Page 1 of 2

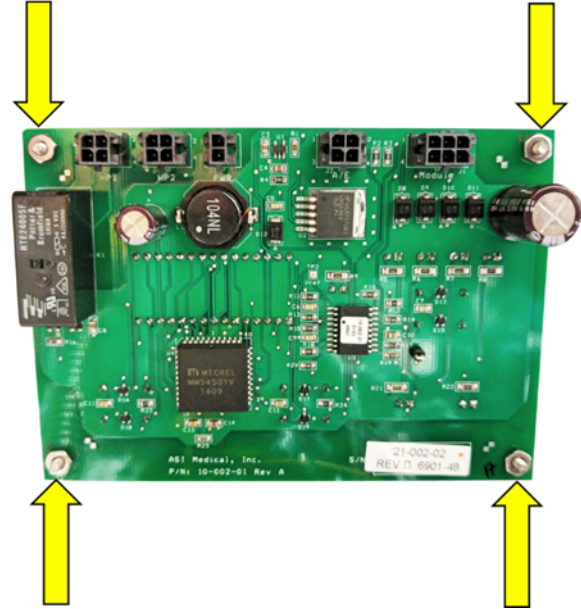
Fig. 1

3. Locate four nuts on the control/button board.  
Untighten using a 1/4" nut driver. (Fig. 1)

4. Pull control board away from the plastic overlay on the front of the adapter panel. This should free up the button(s) if sticking.

**NOTE:** The nuts that hold the control board do not need to be removed completely.
