## Technical Guideline

**Micro Irrigation  
Troubleshooting & Component Revisions**

**TG-90-2741.1  
(S,D,T)**

Rev A | 29 Oct 2015 | Page 1 of 9

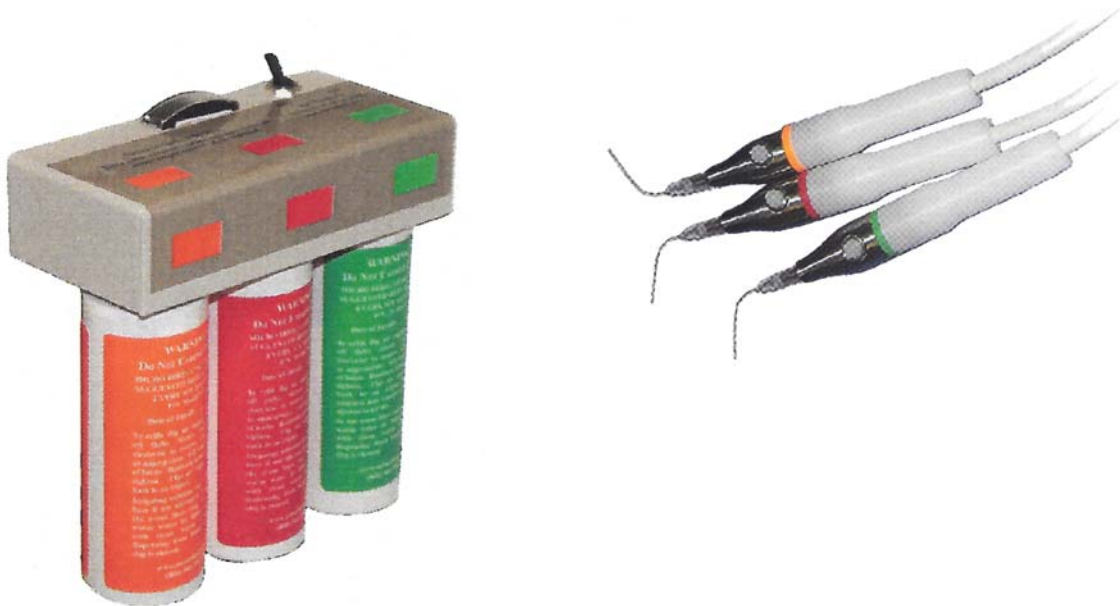
#### Installed Configuration

The bottle is connected to a source of compressed air that is regulated with a maximum pressure of 23 psi. The regulated compressed air flows to a toggle valve that when moved to the on position allows the air into the bottle reservoir through tubing attached to the bottle cap head. The air pressure in the bottle pushes the solution from the bottle into the pick-up tube and out through handpiece tubing to the handpiece. The handpiece has a push button valve similar to a dental air/water syringe that when pressed opens the valve and allows solution to flow out the end of the handpiece.

The end of the handpiece includes a luer type connection. This allows irrigation needles/cannulas provided by others to be attached to the handpiece. A flow control valve knob located on the dental unit allows the dentist to change the rate of drip of solution from a slow to steady drip rate.

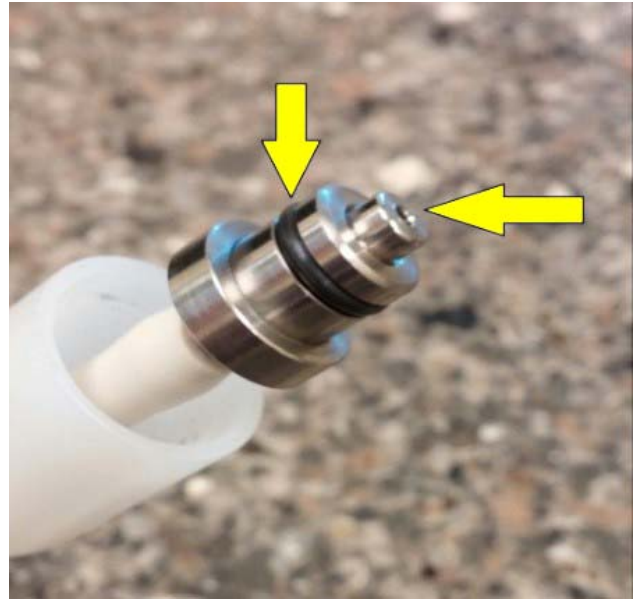
Fig. 1

### Leaking solution from bottom of handpiece is identified:

- Detach the handle from the handpiece body. Check O-Ring on the Connector Valve to ensure it is not damaged or cracked. Soak connector in warm water and repeatedly press valve to break up dried solution build-up. (Fig. 1)

- Check Connector Valve and O-rings.
  - Standard Micro Irrigator The connector has a spring loaded valve. Verify function if there is dried solution build-up by soaking, depress valve to break up dried solution. See *Technical Note - Maintenance, Connector Valve*. Replace, if needed. (PN 95-0234)
  - Check for damaged or cracked O-ring, 9mm. Replace if, needed. (PN 95-4034)
  - Active Irrigator The connector has 5mm O-rings. Replace if needed. (PN 95-4035)
- Standard Irrigators. Remove and slide down the white handle (metal coupler for hourglass design). Check tubing is secure to barb of connector valve.

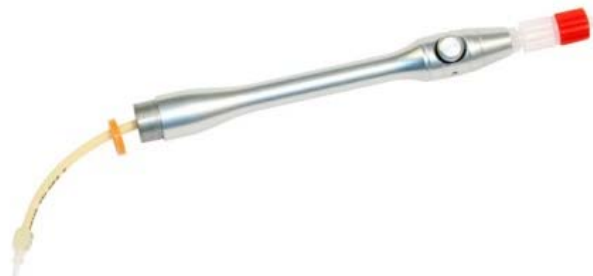
Fig. 2

- Handpiece/Micro Irrigator (PN 95-0154) on systems 08/2006 and prior. No valves. Tubing/Irrigator Handpiece/Articulating (Pharmed) (PN 95-0155). Locking Luer tips. *Obsolete, Upgrade Recommended.* (Fig. 2)

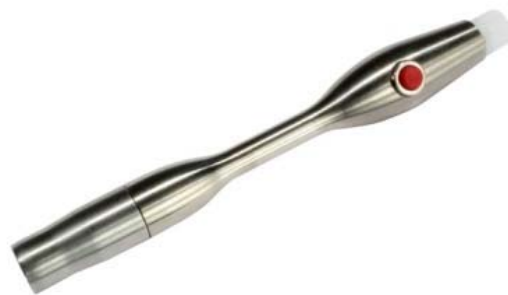
Fig. 3

- Handpiece/Micro Irrigator (PN 95-0270) on systems 09/2006 through 02/2008. Two valves Valve/Irrigator (Button) (PN 95-0192W) and Connector Valve, Standard Irrigation (PN 95-0234). Locking Luer tips. Metal coupler. *Obsolete, Upgrade Recommended.* (Fig. 3)

- Soak the handpiece past the coupler overnight in warm water to break up dried solution. Untighten coupler. Replace handpiece, if necessary, or upgrade to current Micro Irrigator Handpiece without metal coupler. (PN 95-0271; PN95-0115 -or- PN95-0115L)

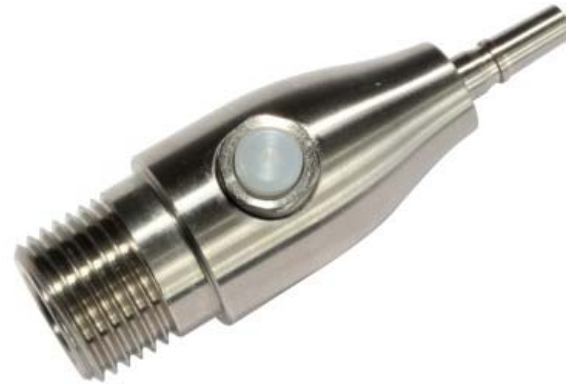
Fig. 4

- Handpiece/Micro Irrigator (PN 95-0271) [07/22/13-Present]. Two valves. Valve/Irrigator (Button) (PN 95-0192W) and Connector Valve, Standard Irrigation (PN 95-0234). Slip Luer tips. Plastic white handle/nut. *Obsolete, Upgrade Recommended.* (Fig. 4)

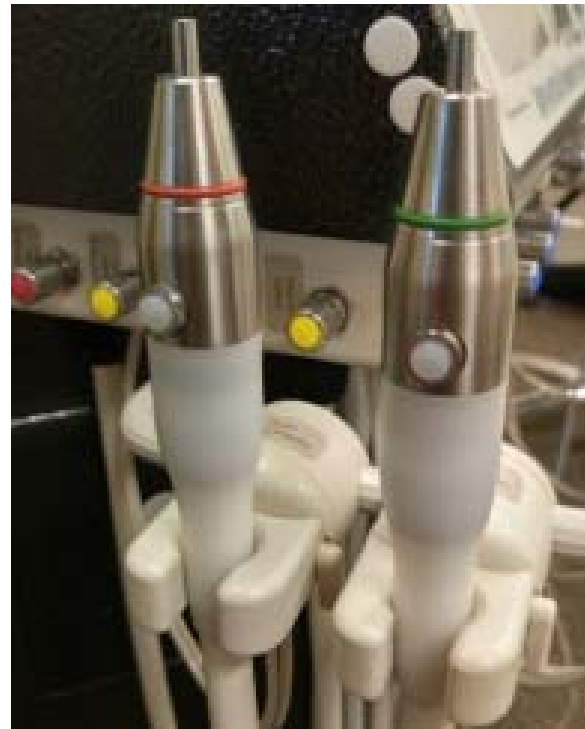
- Handpiece Active Irrigator - Positive (PN 95-0325) (11/19/14-Present) Two valves. Irrigator Valve - Replacement, Active IrriVac (PN 95-0245[P]) and Connector Valve, Active Irri-Vac Positive (PN 95-0225). Active Orbiter Assembly (PN 95-4045). Active Irrigation Nose Cones (PN 95-3026R, G or O). Slip Luer tips. Plastic white handle/nut. (Fig. 5)
- Handpiece Active Irrigator - Negative (PN 95-0325) Two valves. Irrigator Valve - Replacement, Active IrriVac, (PN 95-0245[N]) and Connector Valve, Active Irri-Vac, (PN 95-0226). Active Orbiter Assembly (PN 95-4045). Active Irrigation Nose Cones (PN 95-3026R, G or O). Slip Luer tips. Plastic white handle/nut.
- Handpiece Active Irri-Vac Standard Irri-Vac (PN 95-0227)

- Verify the lock-out lever on side of the holder is pointing straight down to the floor.
  - Orbiter is frozen with dried solution. Soak handpiece, (See TG-PM-0002 and Preventative Maintenance for Irrigation video). (Irrigator Rinse Cup PN 95-0283)
  - If soaking does not resolve, check for cracked or damaged O-Rings. Replace Sonic Orbiter Assembly, if needed. (PN 95-4045)
  - If damage to orbiter is identified, replace Active Orbiter Assembly. (PN 95-4046)
-

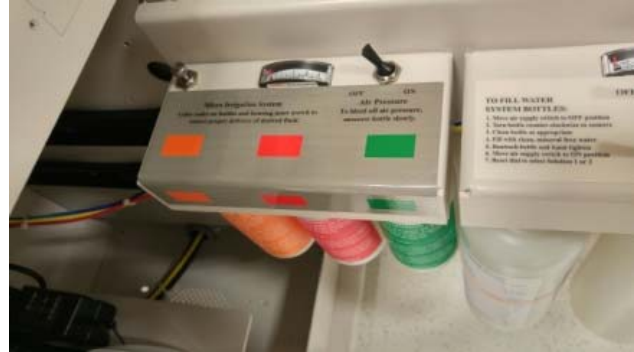
- (06/13/13-Present) For irrigation systems, upgrades are available for newer version of bracket systems. (Fig. 6)
  - Single Solution (PN 95-0116S)
  - Dual Solutions (PN 95-0116D)
  - Triple Solution (PN 95-0116T)
